M/V Eagle Bay
Hull No. 865

SNO 865 865
YARD: SHIKOKU, JAPAN
STAL'S NO: B-9673.0076

9673.0076-14A

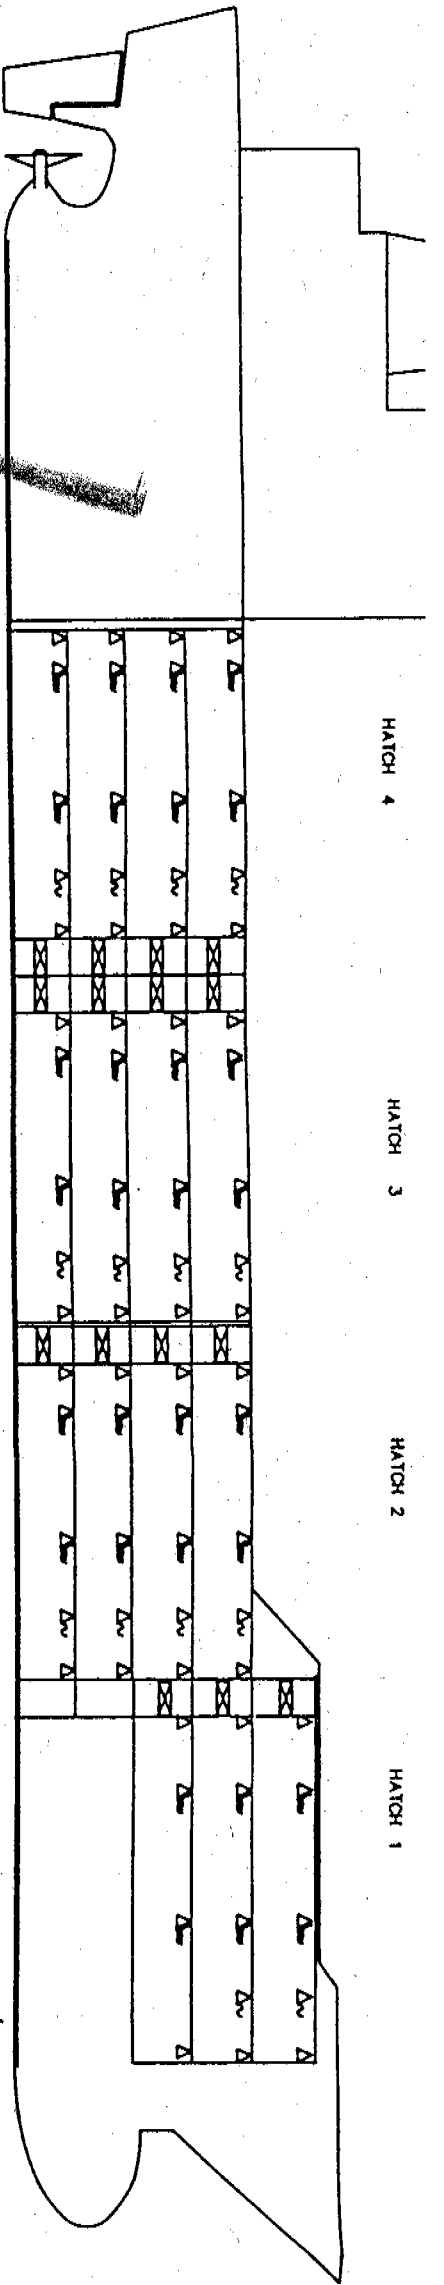
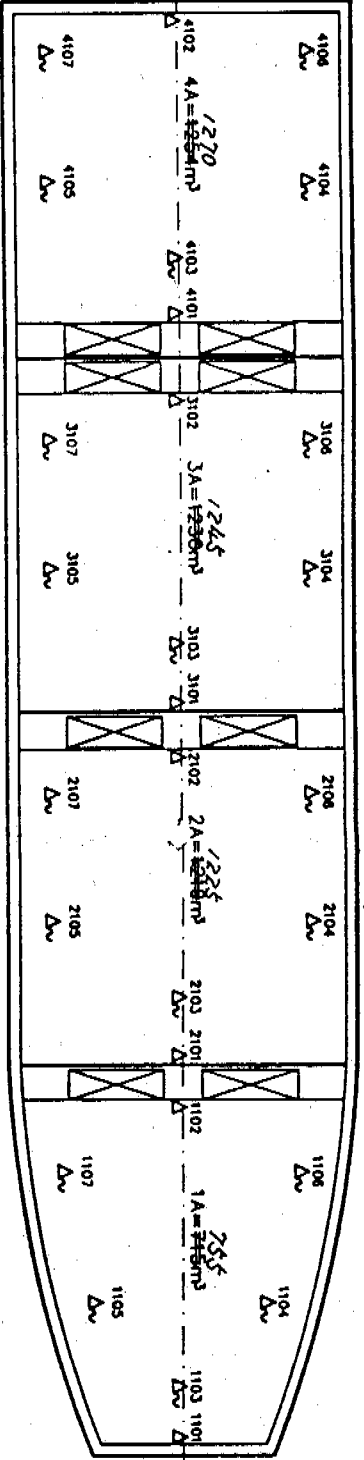
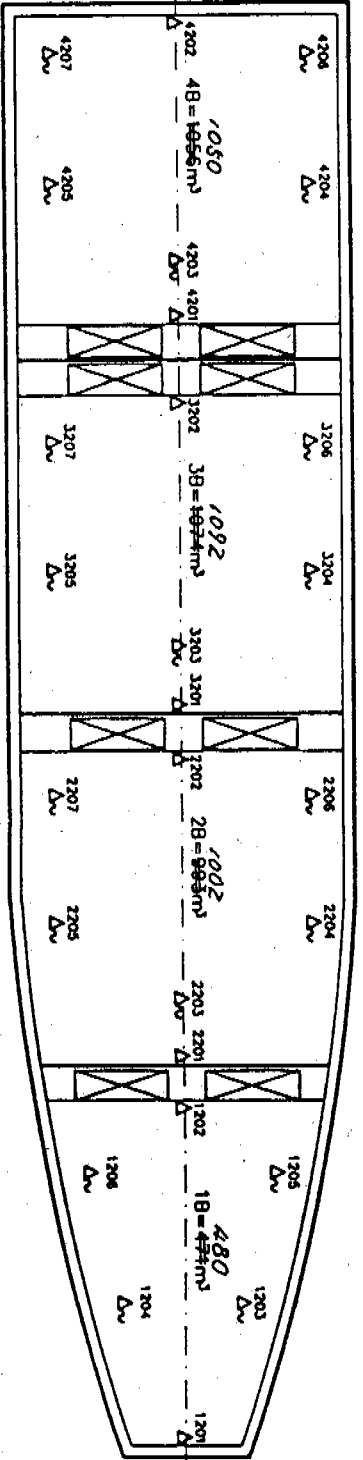
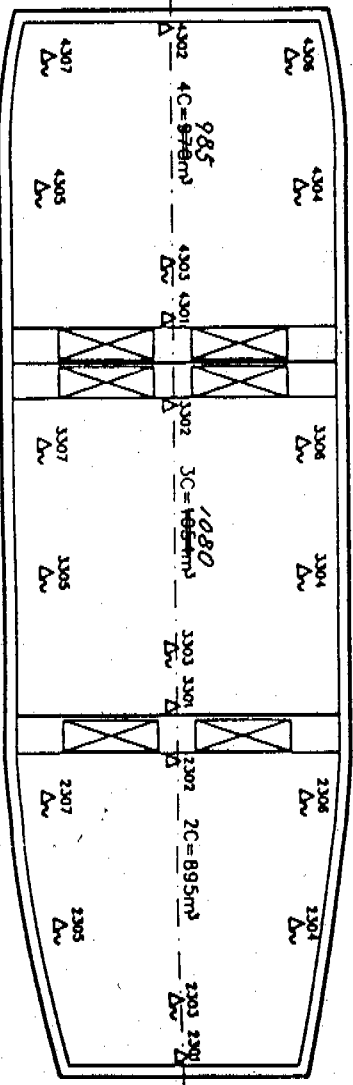
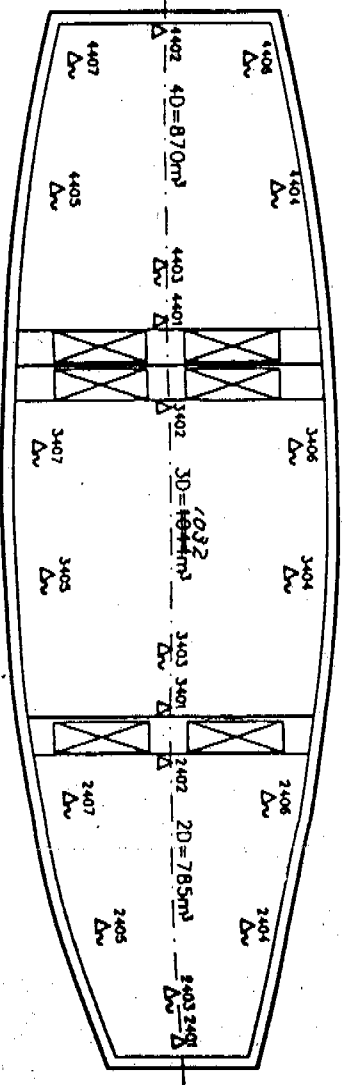
SYMBOL	QUANTITY	DESCRIPTION
△	30	USDA AIR SENSOR, FIXED
∇	74	USDA FRUIT SENSOR, PORTABLE

AIR SENSORS (FIXED)
SHALL BE LOCATED ON THE CENTRELINE OF THE VESSEL, APPROXIMATELY 30 CENTIMETERS FROM THE CEILING.
SHALL BE ATTACHED IN SUCH A WAY THAT THEY DON'T TOUCH THE BULKHEAD AND ARE PROTECTED FROM DAMAGE CAUSED BY THE CARGO.

FRUIT SENSORS (PORTABLE)
SHALL BE STORED IN RECESSED BOXES TO BE PROTECTED FROM DAMAGE WHEN NOT IN USE.
PROPOSAL OF BOXES FOR USDA FRUIT SENSORS. SEE DRAWING F-22731.
