Atlantic Mermaid

Hull 146 - IMO 9045936

SENSOR ARRANGEMENT

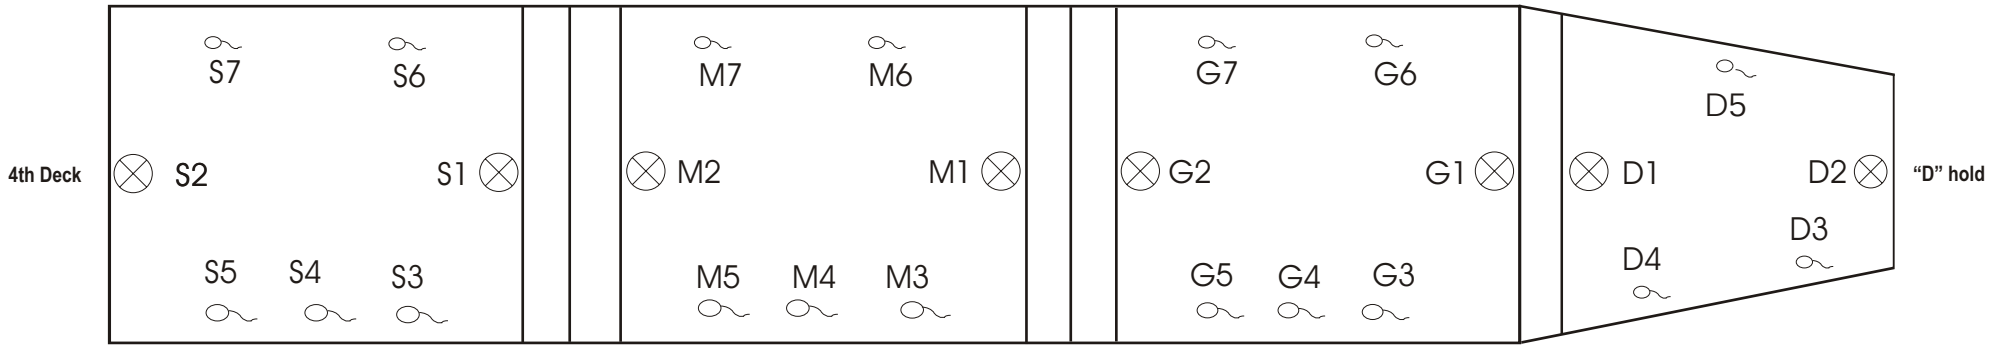
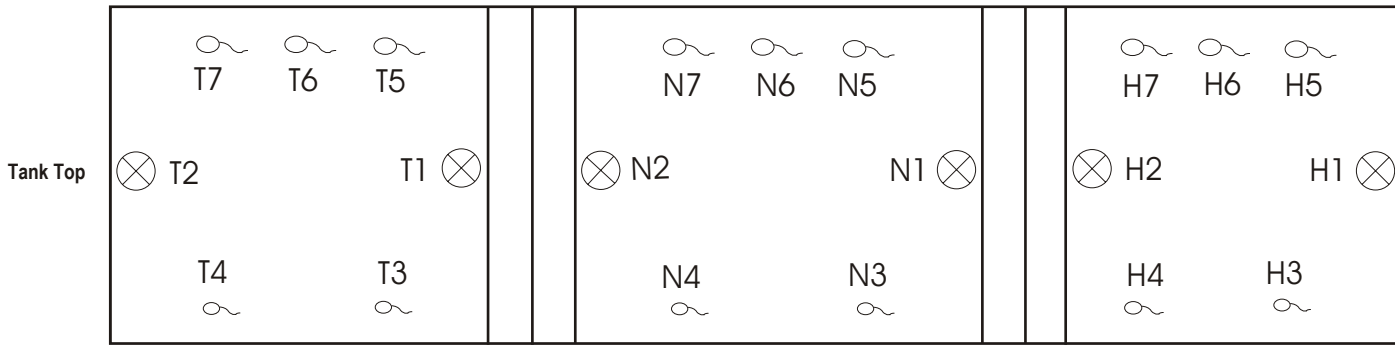
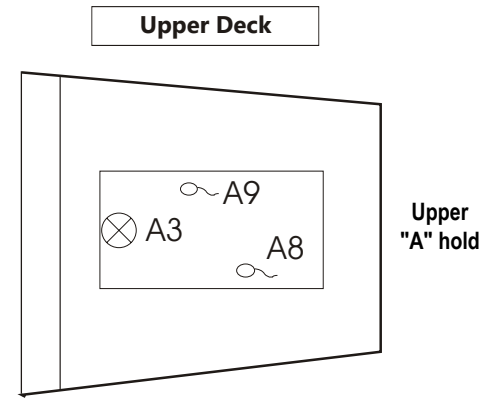
NONFIXED SENSOR
 FIXED SENSOR

NO 1
USDA
RECORDER

A1~A9
B1~B7
C1~C6
D1~D5

NO 2
USDA
RECORDER

E1~E8
F1~F7
G1~G7
H1~H7

NO 3
USDA
RECORDER

J1~J8
K1~K7
M1~M7
N1~N7

NO 4
USDA
RECORDER

P1~P9
R1~R7
S1~S7
T1~T7

Corrected: sensor number/ID D5 in hold 1; side-view diagram of holds 1, 2, 3; deck/compartments labels; and added IMO number.
 [USDA APHIS PPQ - Field Ops, Raleigh NC, 2016-07-27]
