SENSOR ARRANGEMENT FOR U. S. D. A

M/V Washington

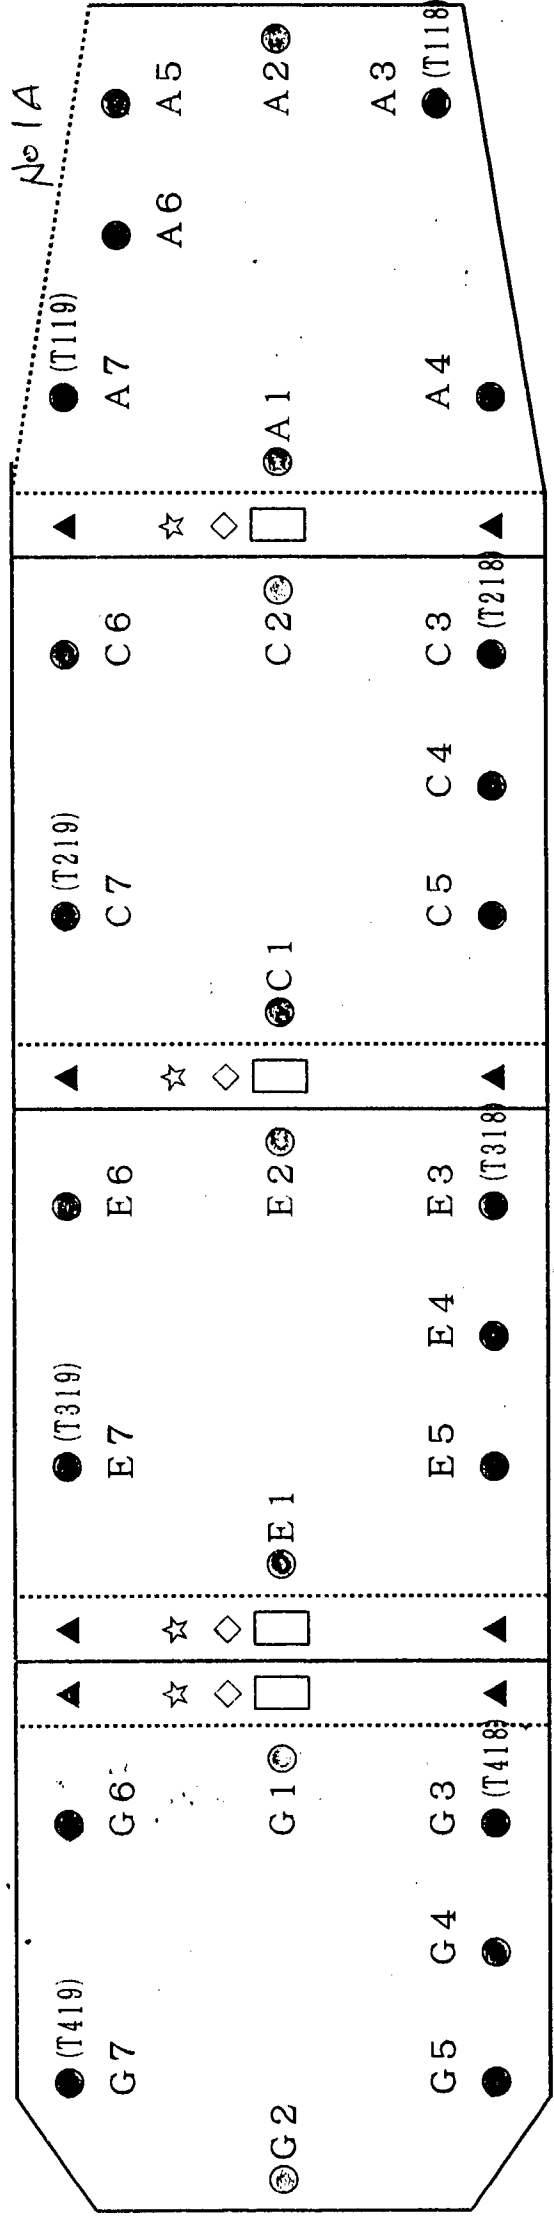
A D E C K

NO. 4 CARGO SPACE NO. 3 CARGO SPACE NO. 2 CARGO SPACE NO. 1 CARGO SPACE

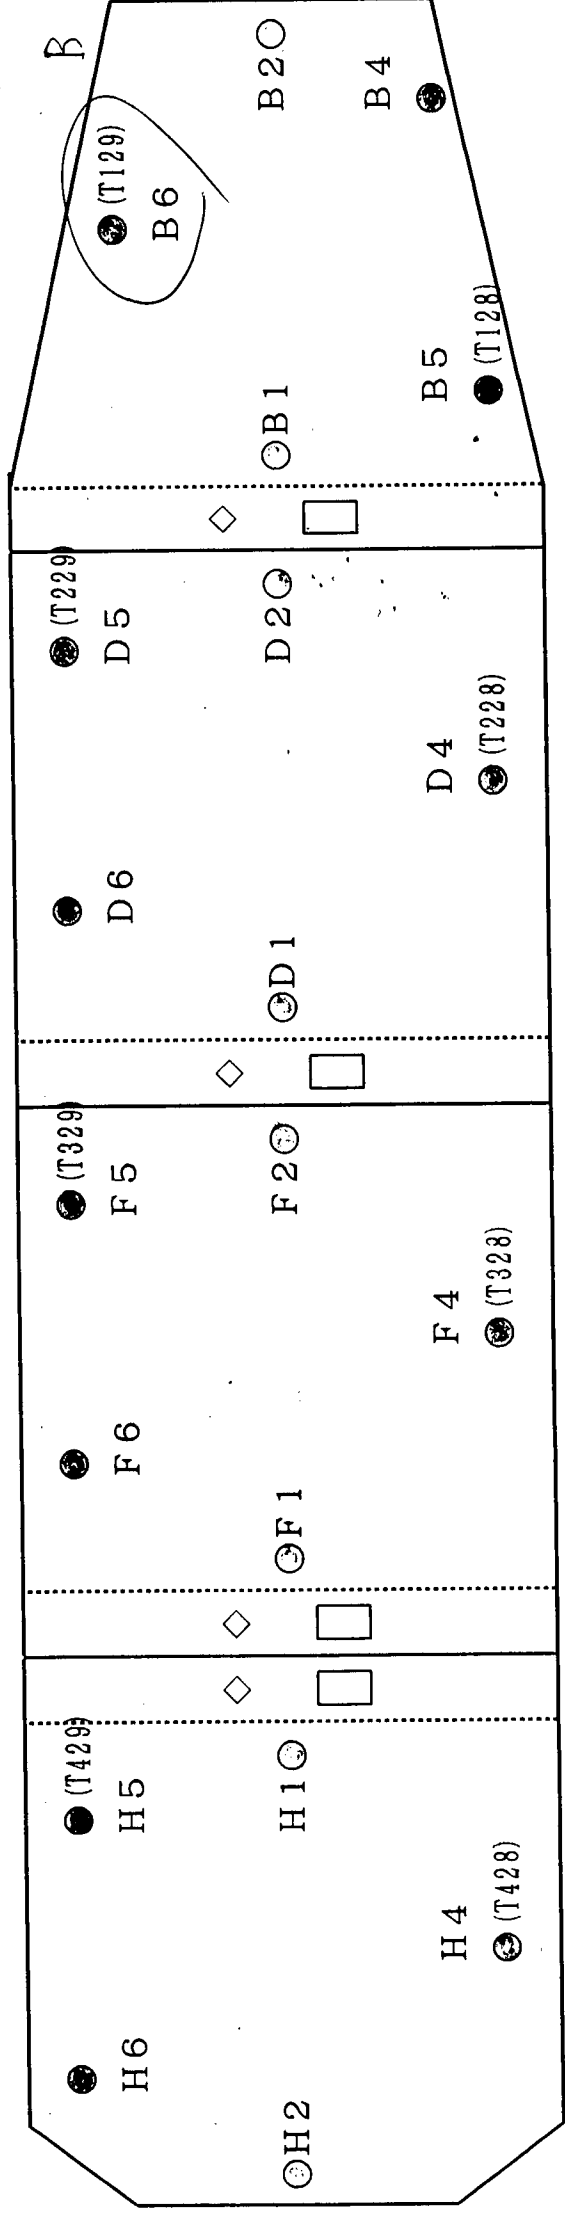
B
D
E
C
K

NO. 4 CARGO SPACE NO. 3 CARGO SPACE NO. 2 CARGO SPACE NO. 1 CARGO SPACE

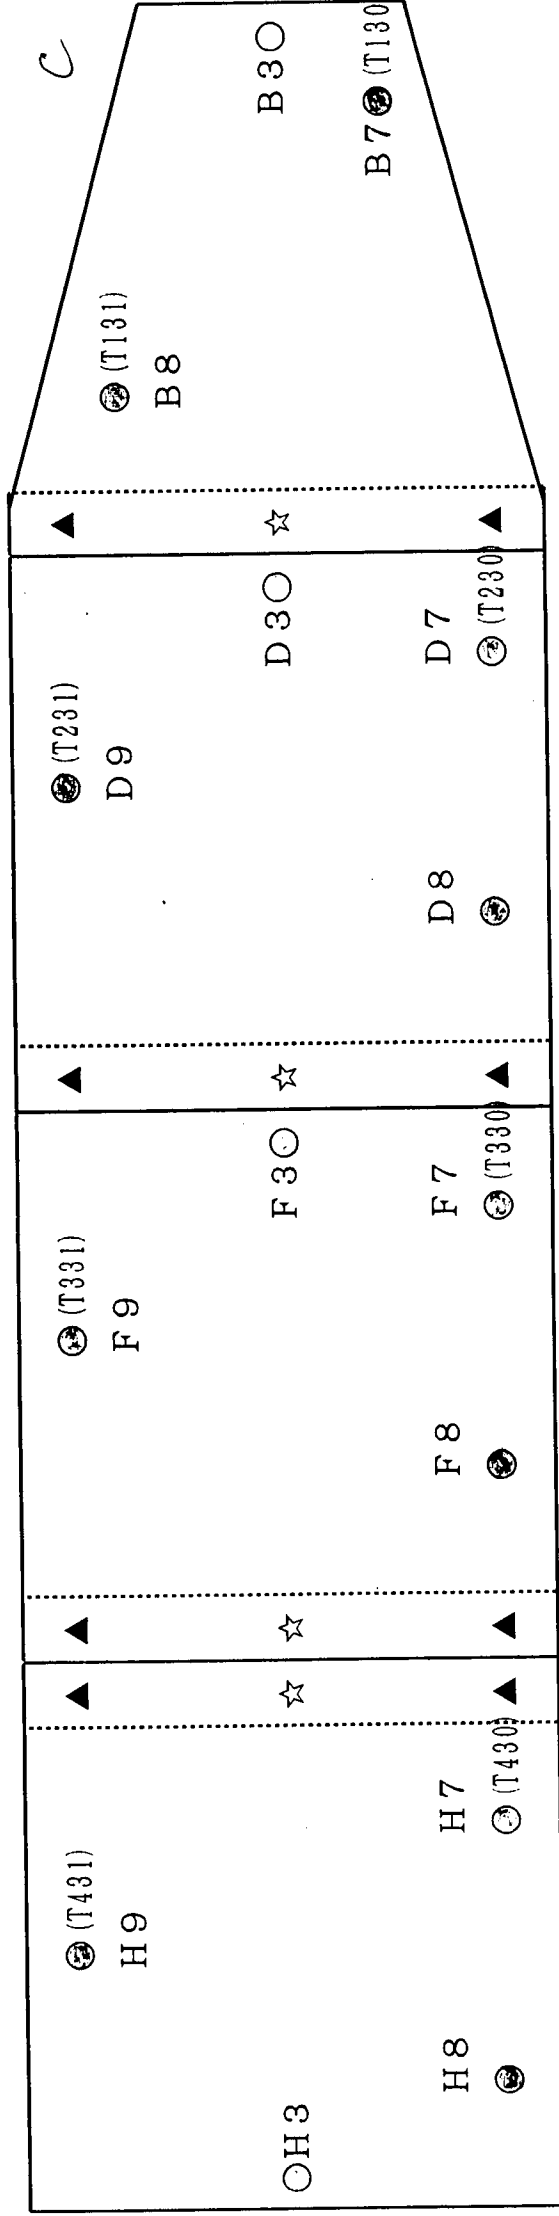
C
D
E
C
K

NO. 4 CARGO SPACE NO. 3 CARGO SPACE NO. 2 CARGO SPACE NO. 1 CARGO SPACE
